Description and analysis of the operation of on-board systems of Tu-154M aircraft No 101

Final Report – Appendix 2. Description and analysis of operation of on-board system of Tu-154M aircraft No 101

DESCRIPTION OF DAMAGE TO THE AIRCRAFT

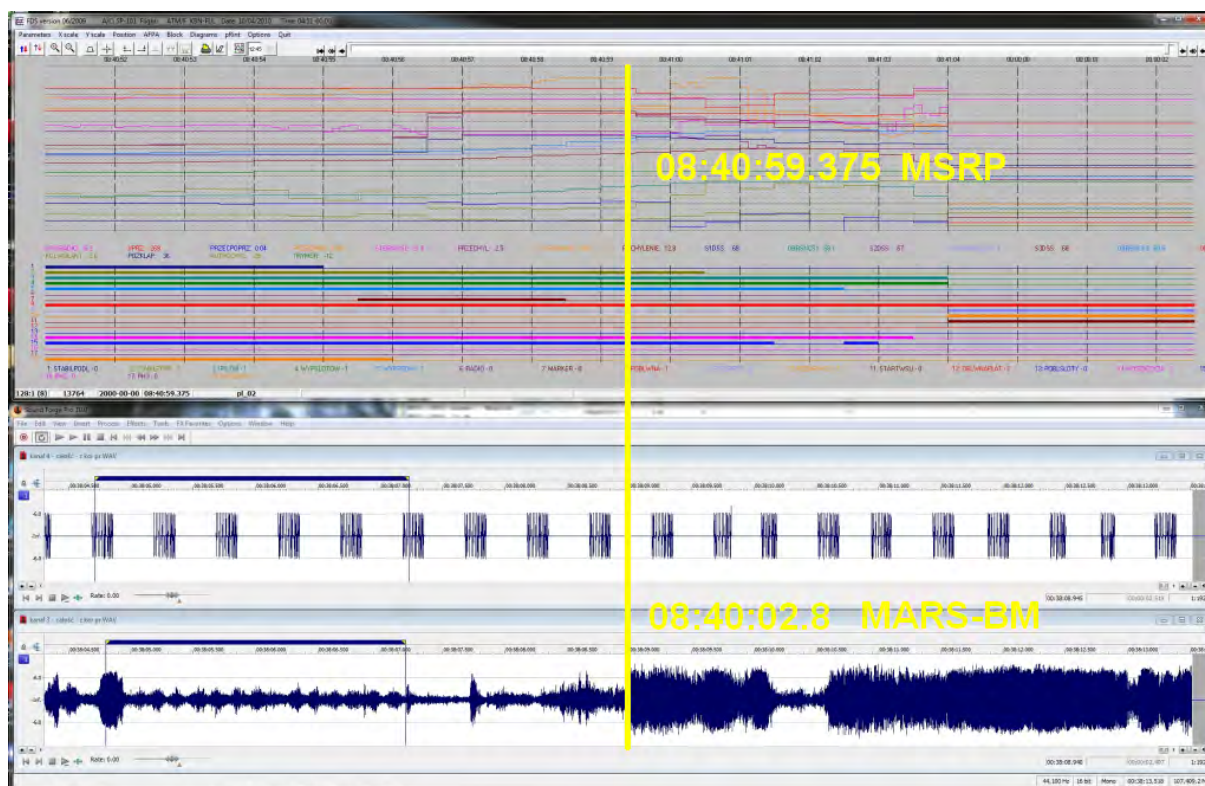
Fig. 6. Dependence of MSRP and MARS-BM time on birch impact

The delay of record in MSRP compared with the MARS-BM was determined by comparing the moment of occurrence of phenomena characteristic of the collision with an obstacle, in consequence of which the tip of left wing was ripped off. According to the MSRP record, the collision with the birch was recorded at 0840:59.375 of MSRP time (an abrupt change in vertical acceleration). According to an analysis of the cockpit voice recorder, the impact noise occurred at 0841:02.8 of MARS-BM time.

The above data shows that MSRP time is delayed by 3.425 s compared with MARS-BM time. A delay of 3 s was adopted for further analyses.

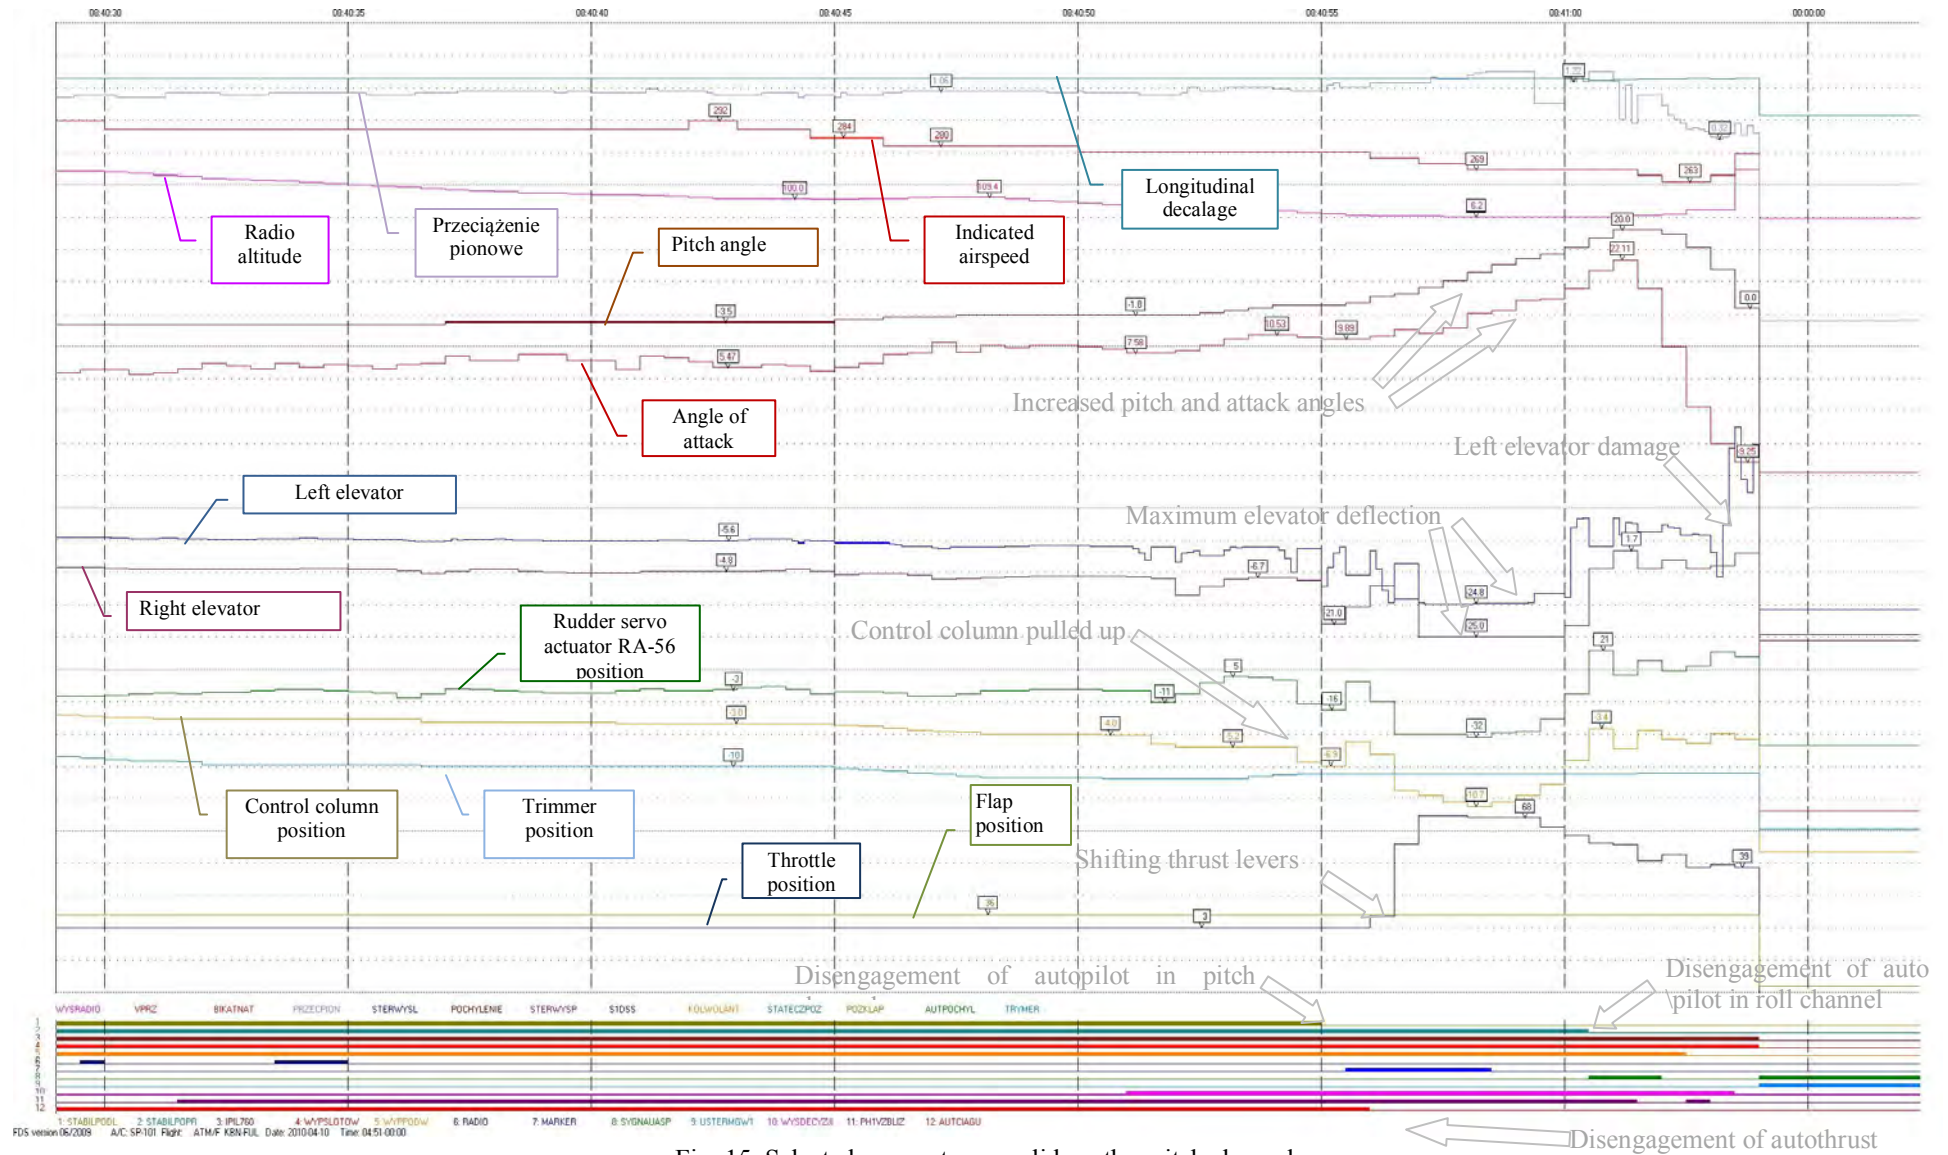
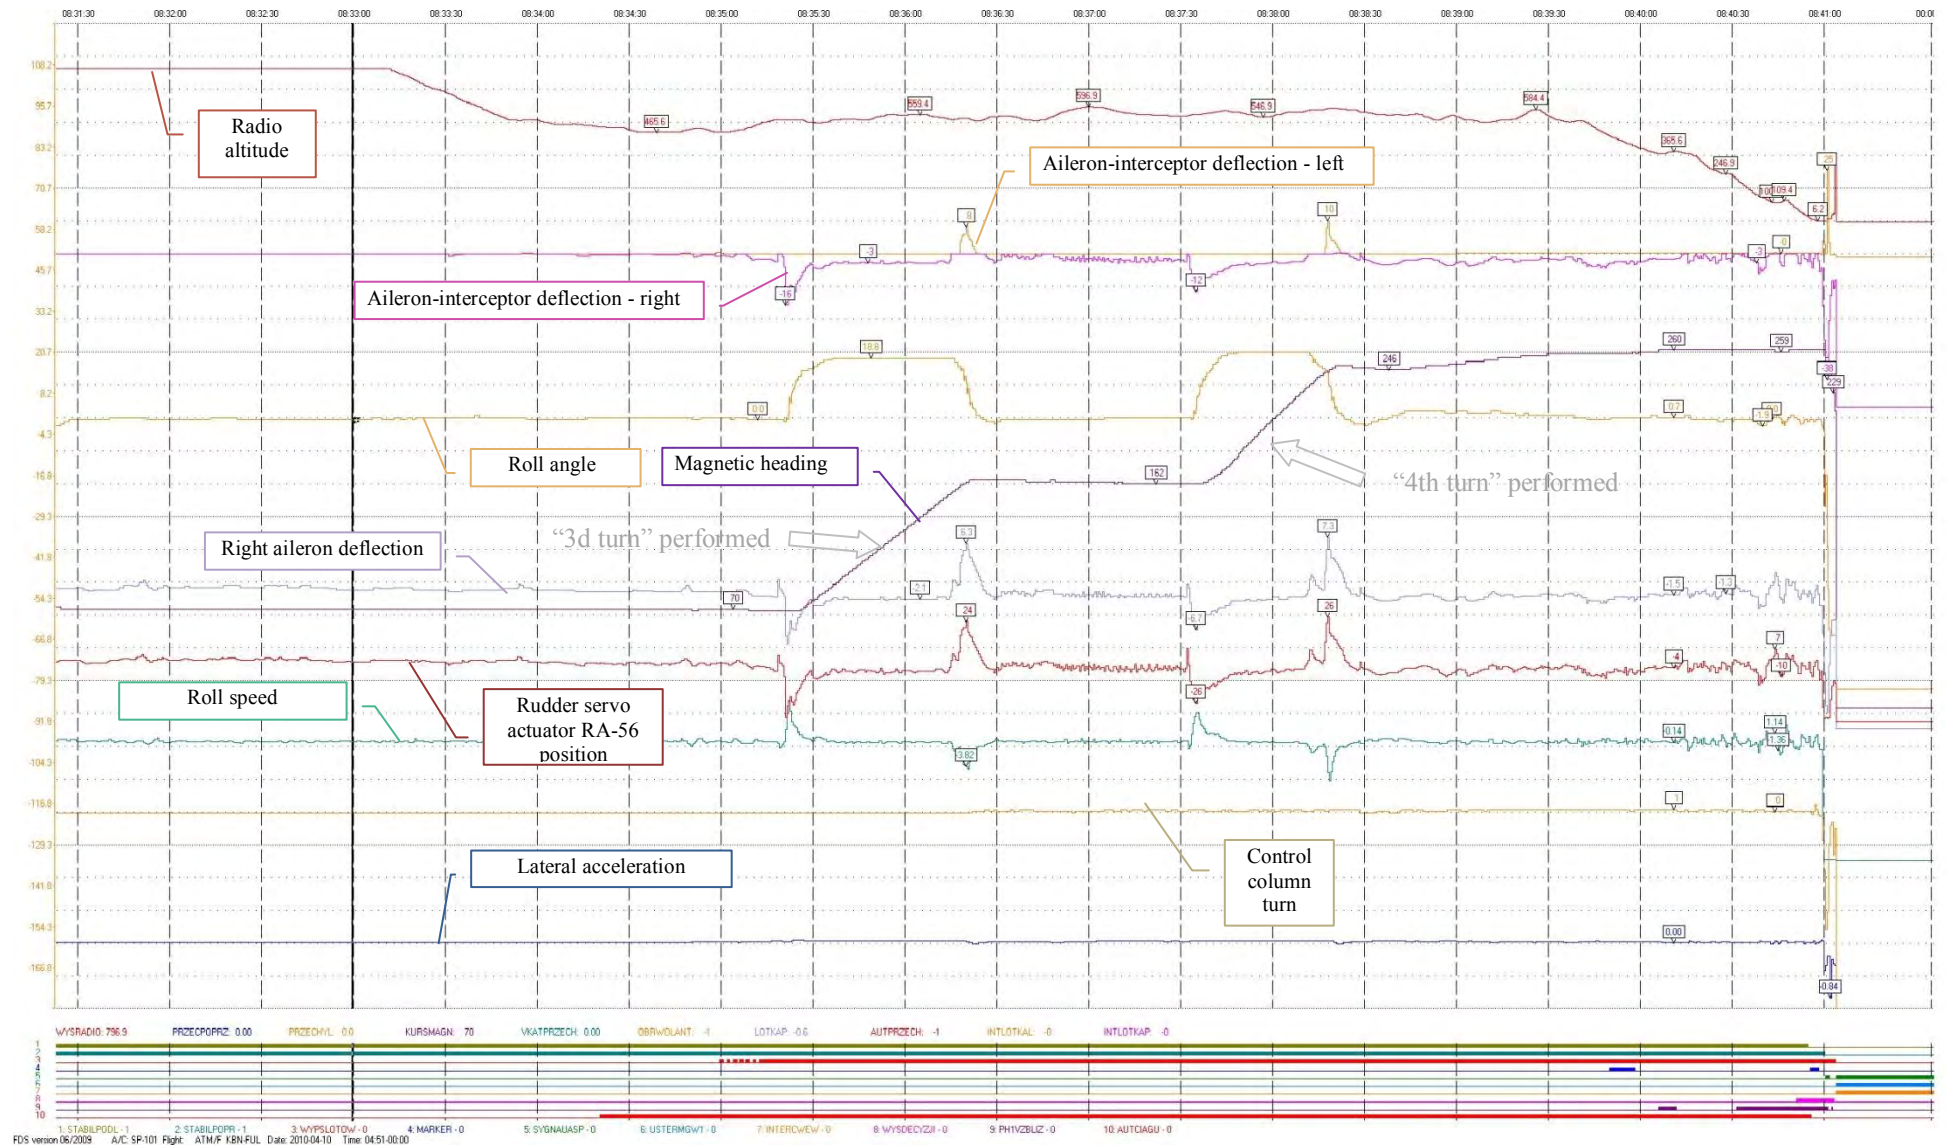
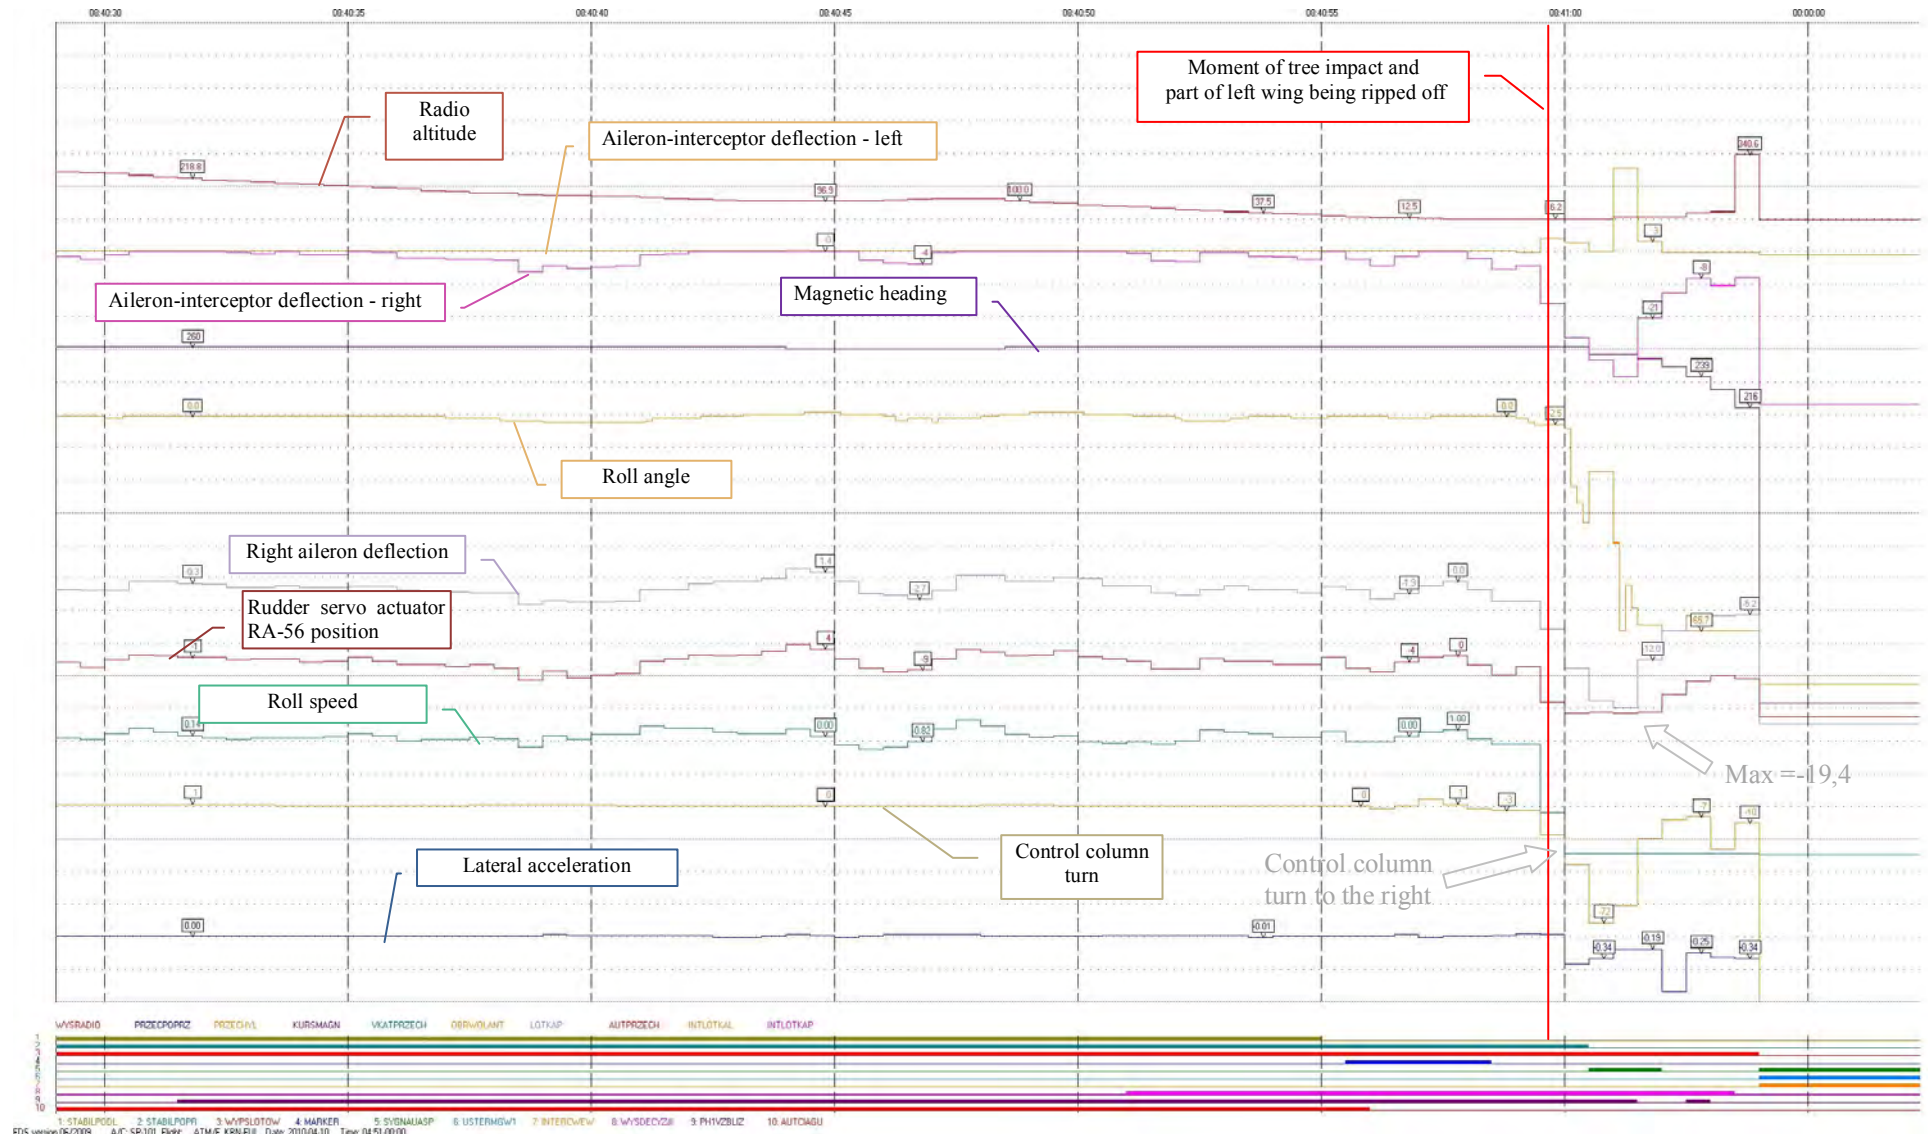
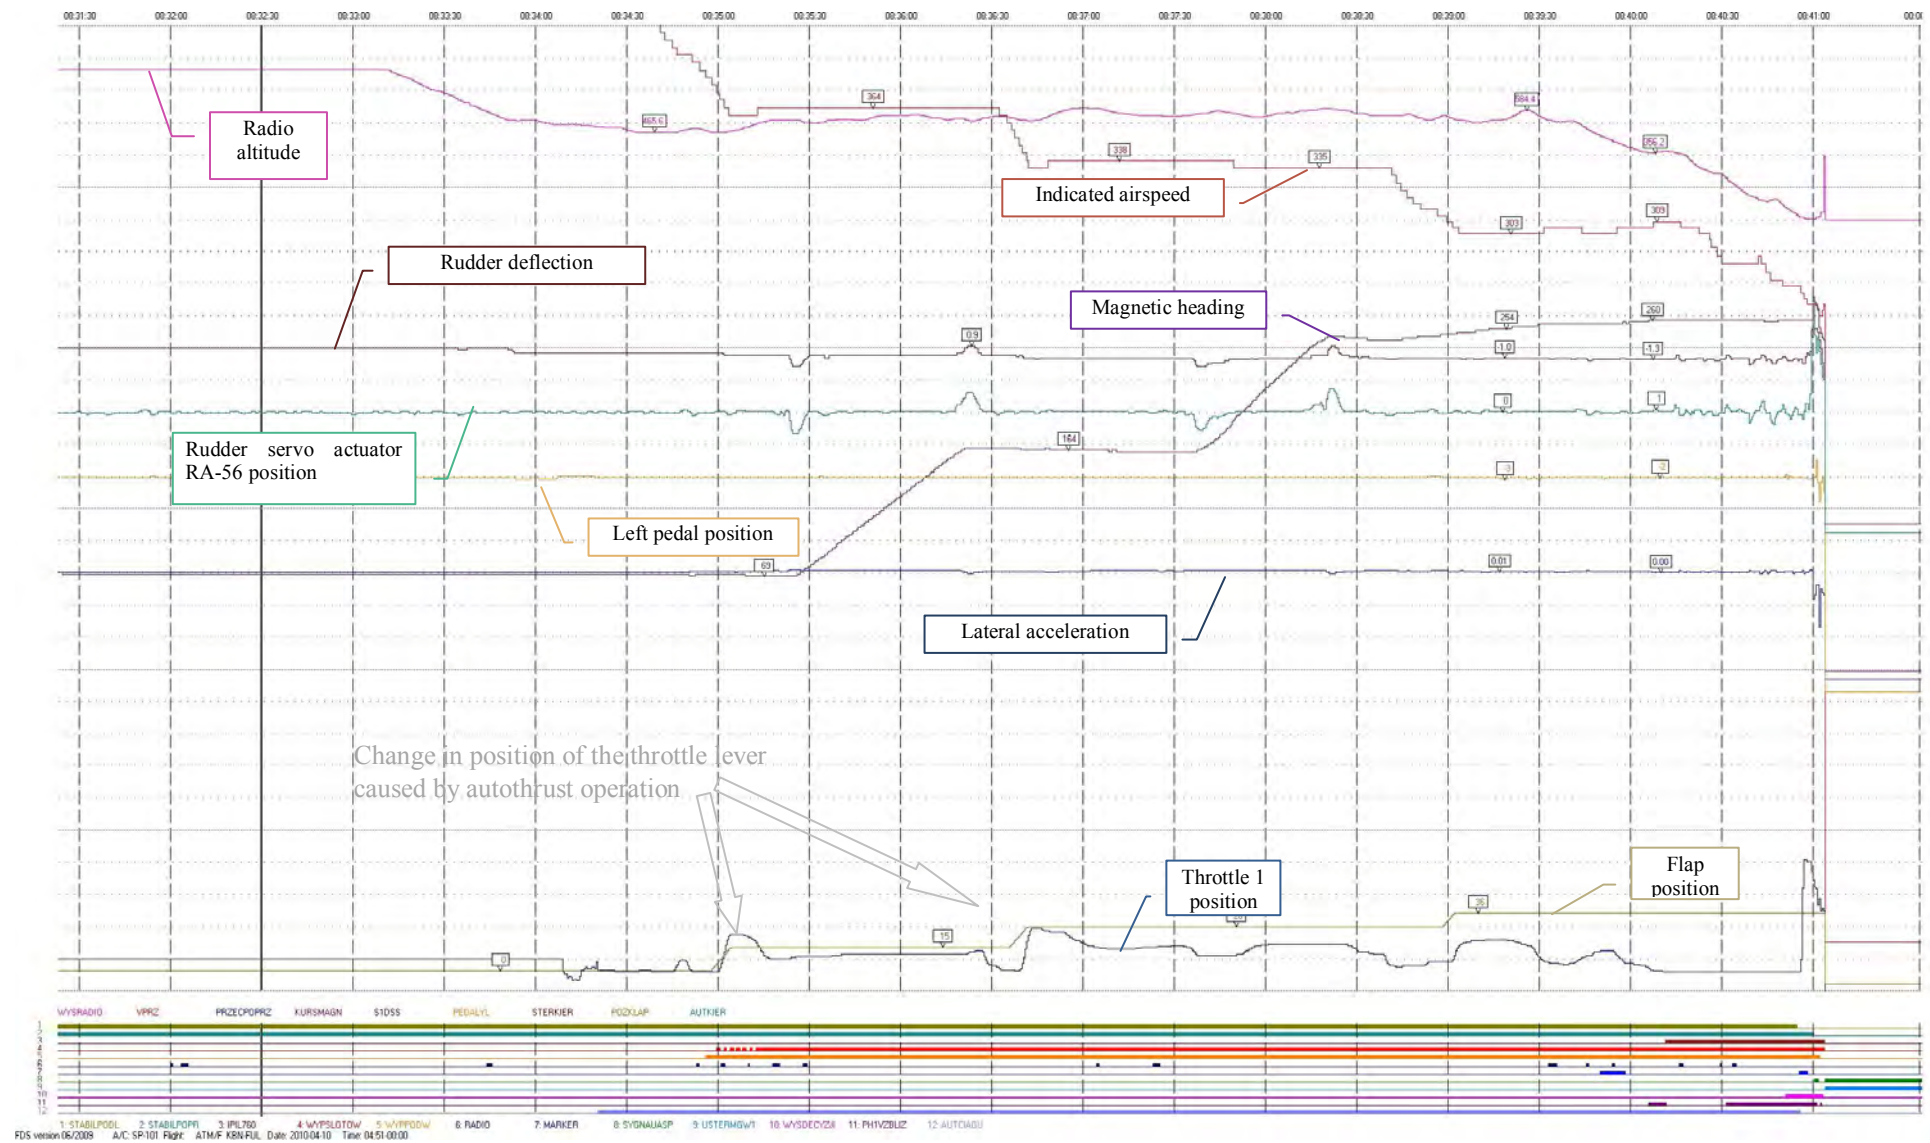
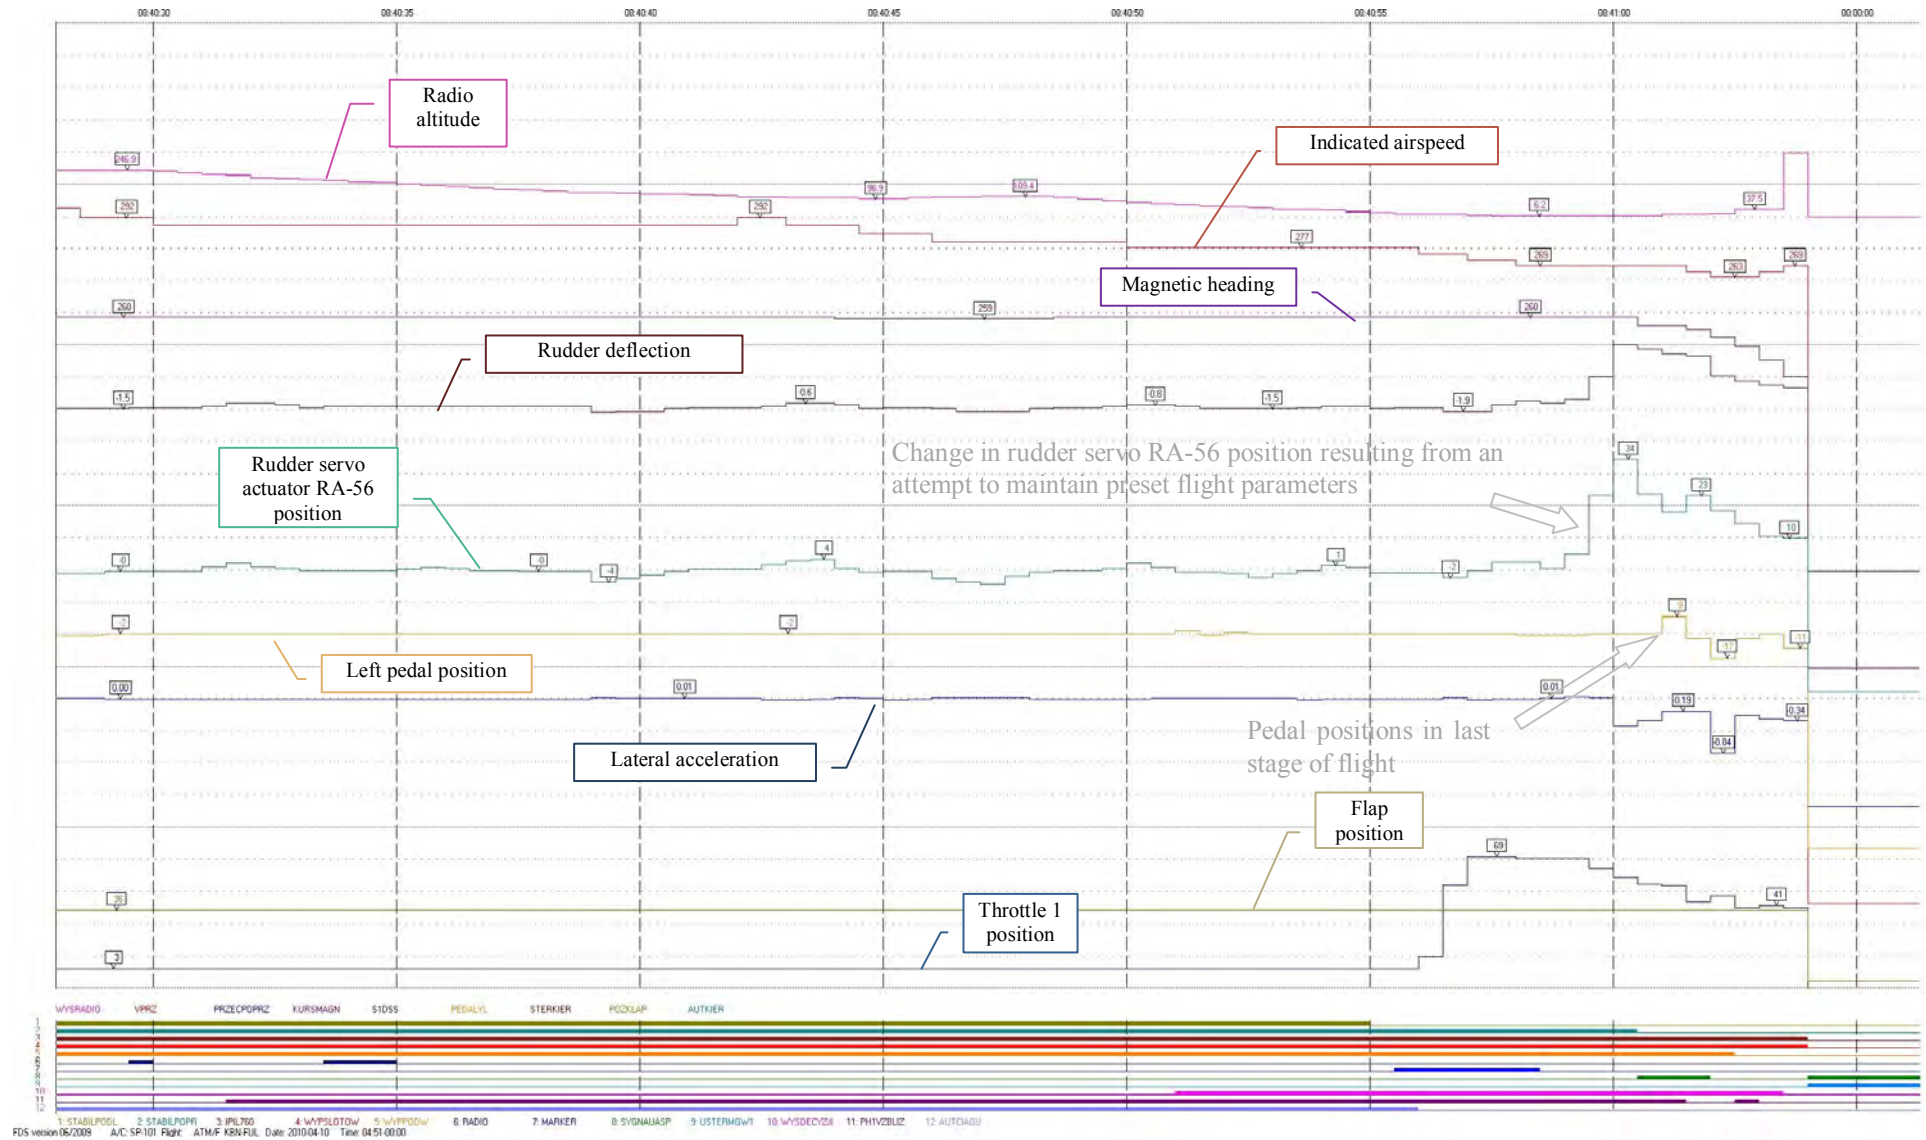
- 1) No anomalies were found in the operation of the ABSU automatic control system. The movements of actuator shafts changing the position of elevators, ailerons, and rudder were fluid and did not extend to reach extreme values.

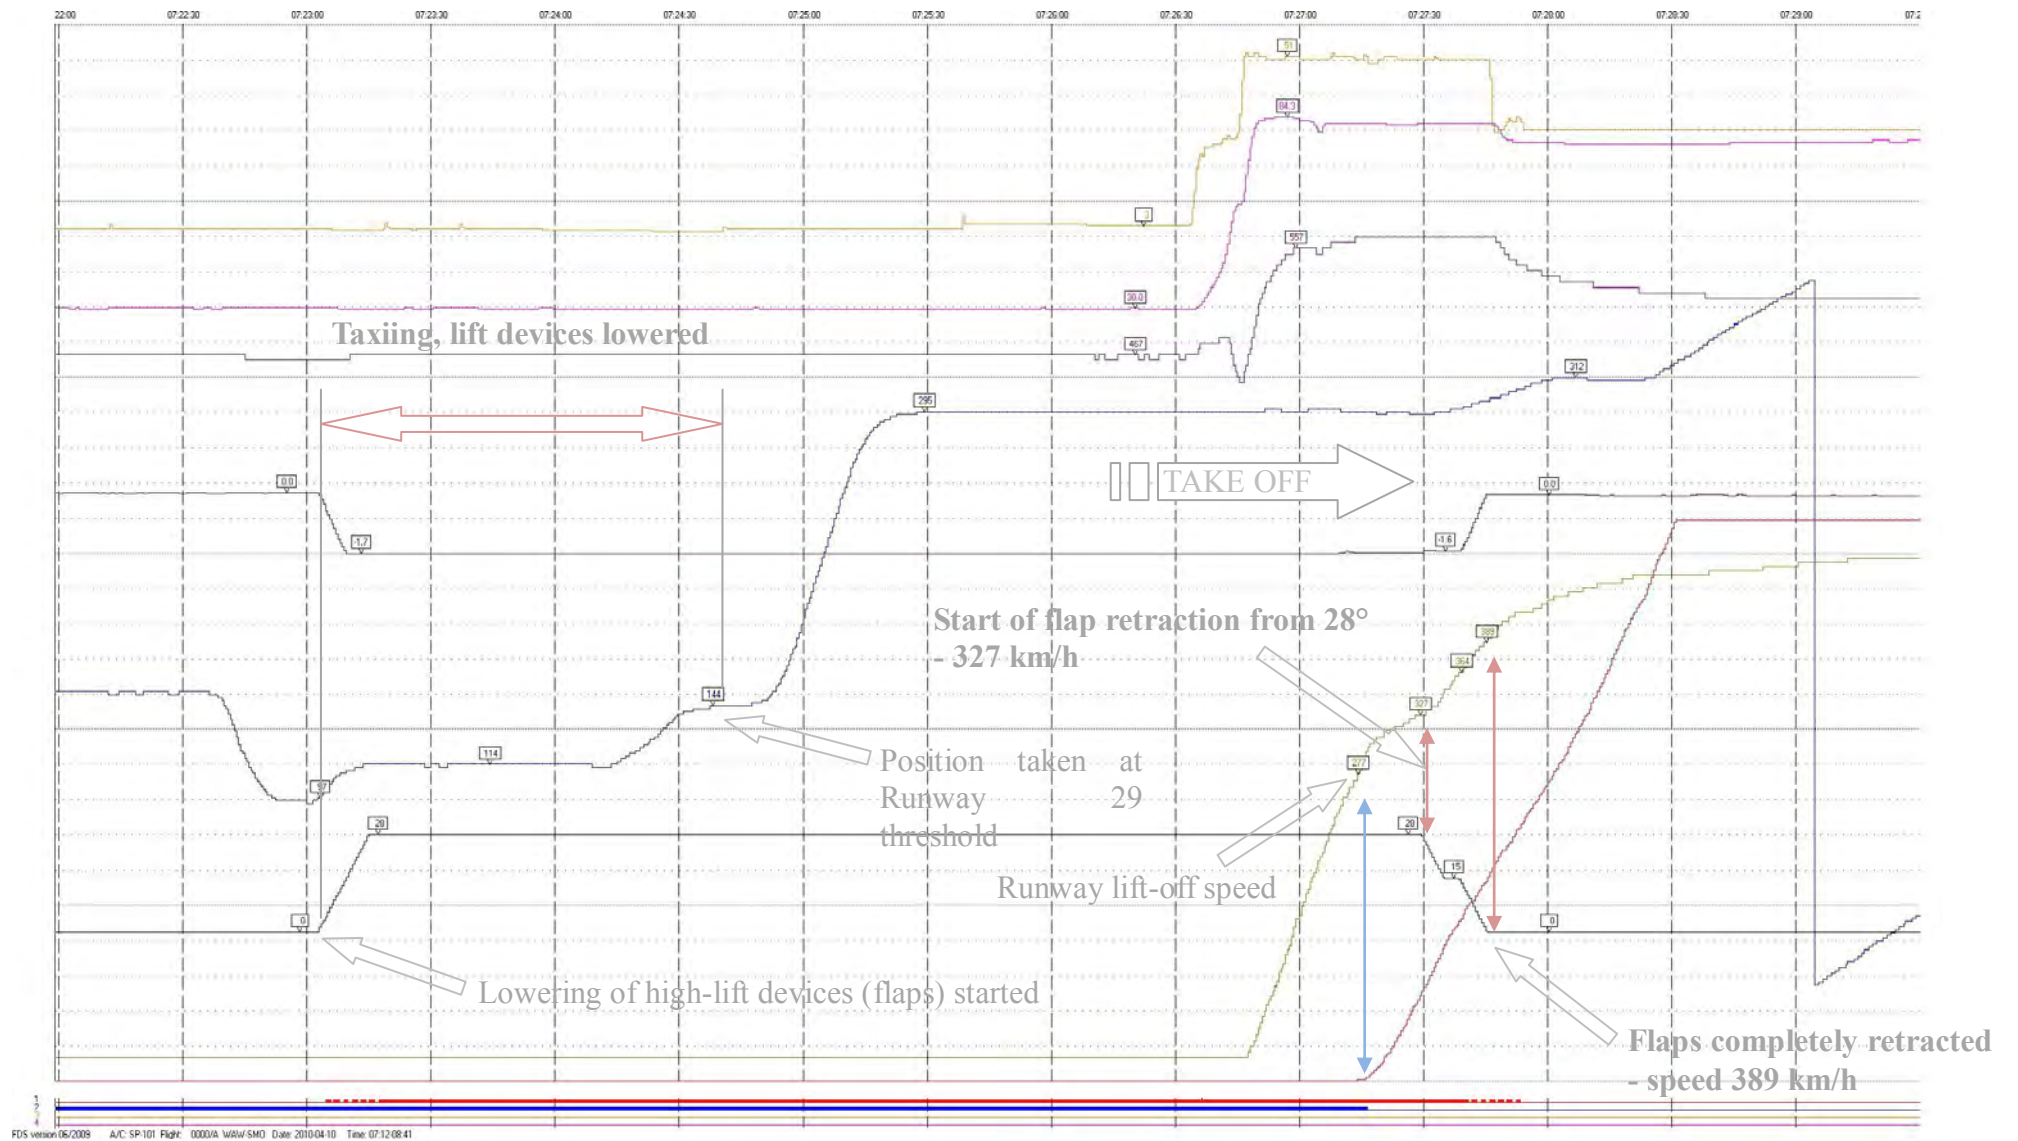
Fig. 28. Selected parameters of the taxiing and takeoff stage

AFPA C5-1			
No	No of procedure	Description of procedure	Duration and values of additional parameters
1.	AL35A	Taxiing, lift devices lowered Fig. 28	Duration: 07:23:04-07:23:07 POZKLAP: 4 WYPSLOTOW: 1

2.	AL35A	Taxiing, lift devices lowered Fig. 28	Duration: 07:24:53-07:25:17 POZKLAP: 28 WYPSLOTOW: 1
3.	AL29A	Retraction of flaps from 28 below V_p < 330 km/h Fig. 28	Duration: 07:27:29-07:27:30 VPRZ: 327 POZKLAP: 27

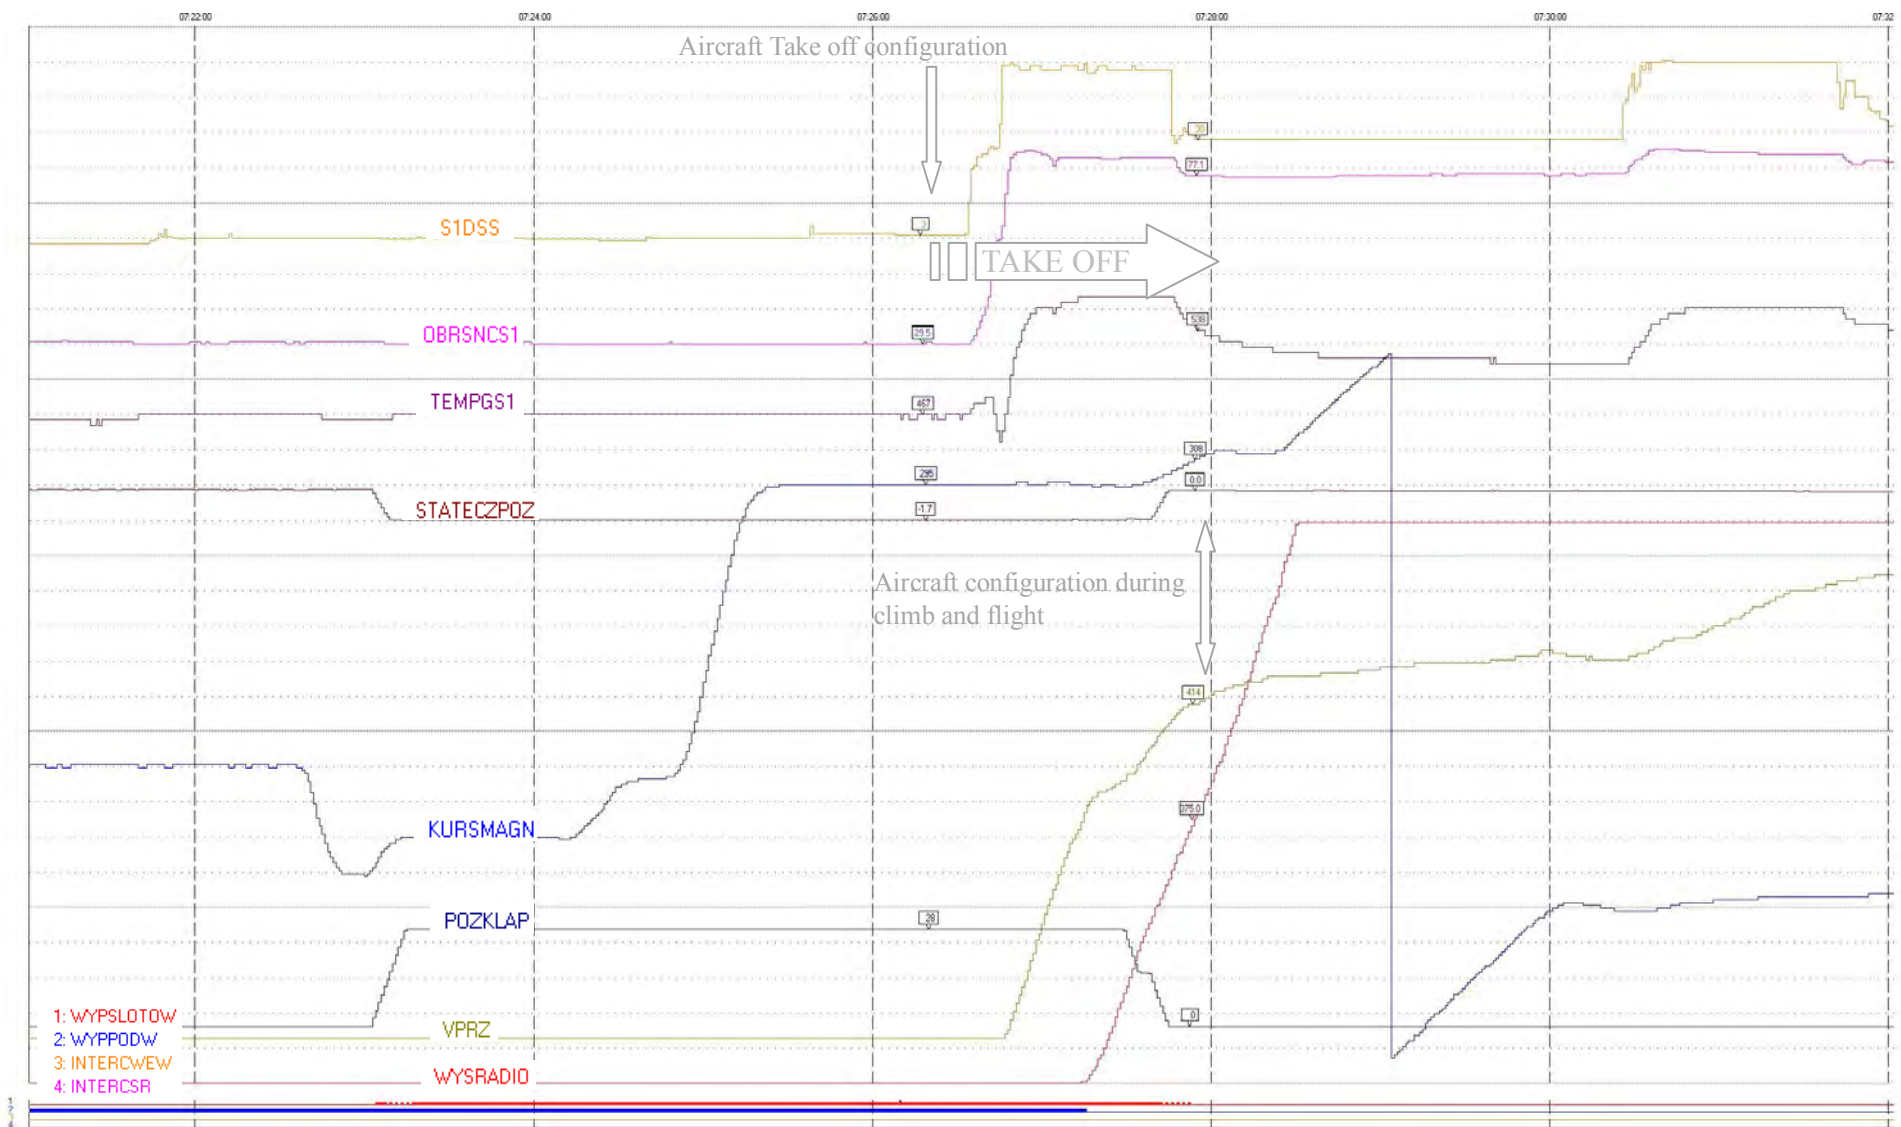
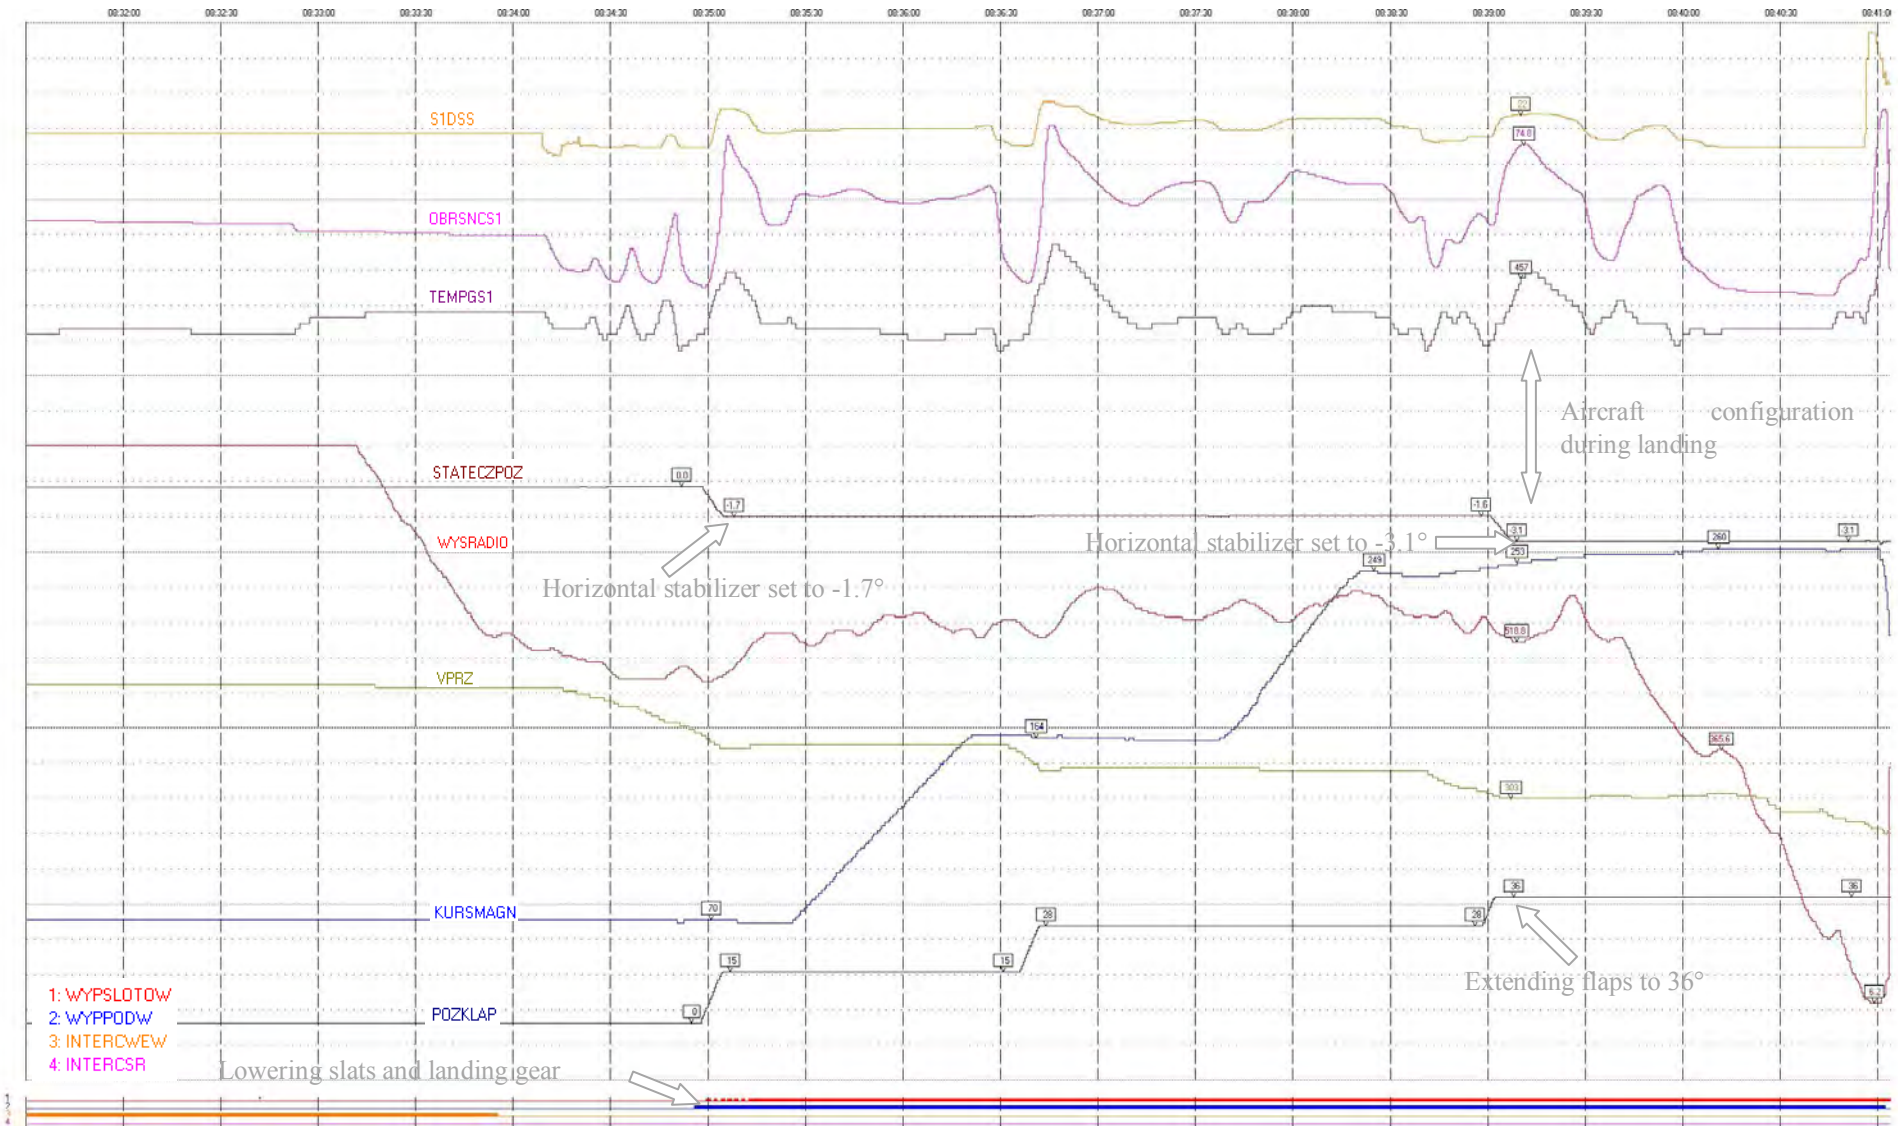
The aircraft configuration during takeoff and during landing was shown in Fig. 30 and in Fig. 31. According to the data presented in the charts, in all flight stages the aircraft had a configuration in compliance with the Tu-154M Flight Crew Operation Manual.

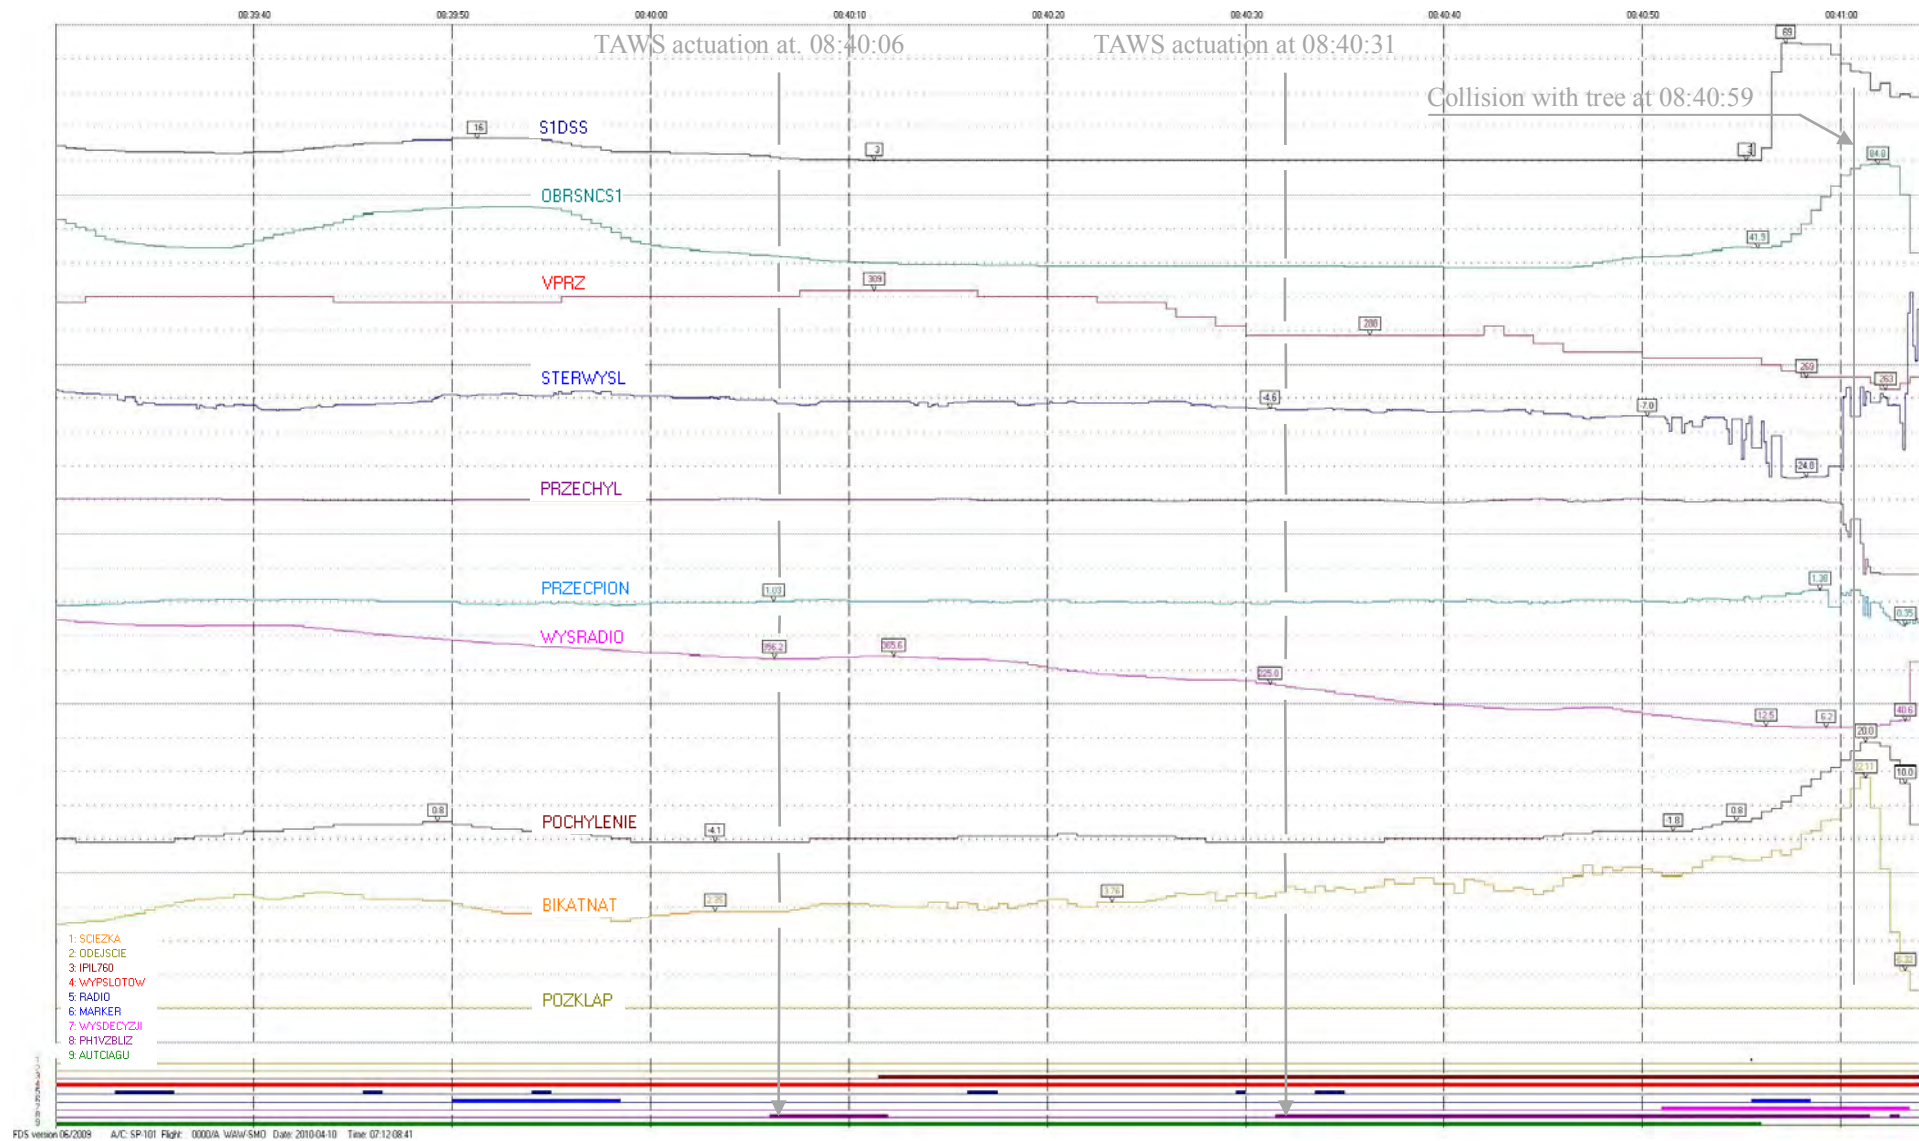
Fig. 32. TAWs signal actuation (parameter PH1/VZBLIZ)

AFPA C5-2 NO WARNINGS OF EXCEEDED LIMITATIONS			
AFPA C5-3			
Ni.	No of procedure	Description of procedure	Duration and values of additional parameters
12.	AT30	AWARIA I.HYDR.1/NIEB. ZIEMIA (FAILURE I. HYDR.1/DANGER GROUND) warning Fig. 32	Duration: 0840:06-08:40:11 VPRZ: 306 WYSBAR: 562 WYSRADIO: 356.2 PH1VZBLIZ: 1
13.	AT30	AWARIA I.HYDR.1/NIEB. ZIEMIA (FAILURE I. HYDR.1/DANGER GROUND) warning Fig. 32	Duration: 0840:31-08:41:01 VPRZ: 288 WYSBAR: 375 WYSRADIO: 218.8 PH1VZBLIZ: 1
08:40:59.375 – impact with tree			
14.	AT30	AWARIA I.HYDR.1/NIEB. ZIEMIA (FAILURE I. HYDR.1/DANGER GROUND) warning	Duration: 0841:02-23:04:11 VPRZ: 263 WYSBAR: 188 WYSRADIO: 37.5 PH1VZBLIZ: 1
15.	AT37	NIESPRAWNOŚĆ RW5 NR 1 (RW5 NO 1 INOPERABLE)	Duration: 0841:02-23:04:11 WYSRADIO: 18.8 WYSBAR: 188 SPRRW5NR1: 0 SPRRW5NR2: 1

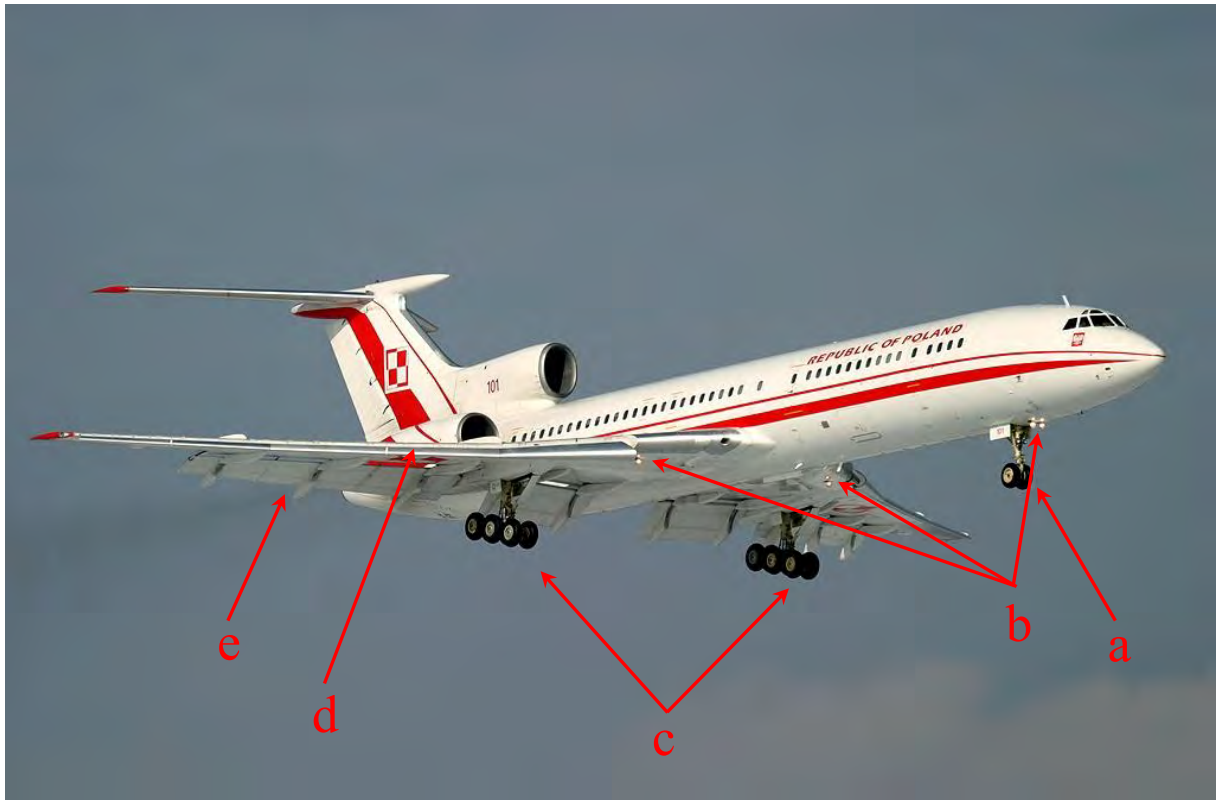
At the time of collision (contact) with the first ground obstacle (the tip of a birch in the vicinity of the inner marker), the configuration of the aircraft Tu-154M, tail number 101, was as presented in Fig. 5.

Fig. 5. Aircraft Tu-154M, tail number 101, in the landing configuration This is confirmed by the extended:
a – Front landing gear;
b – Spotlights;
c – Main landing gear;
d – Slats;
e – Flaps.
